Inspection reference: Sample Small Office

Confidential Inspection Report

Any Street
Natick, MA 01760

Year Built: 1959.
Building Type: Commercial.
Stories: 1
Space Below Grade: None.
Building Size (SF) 3786.

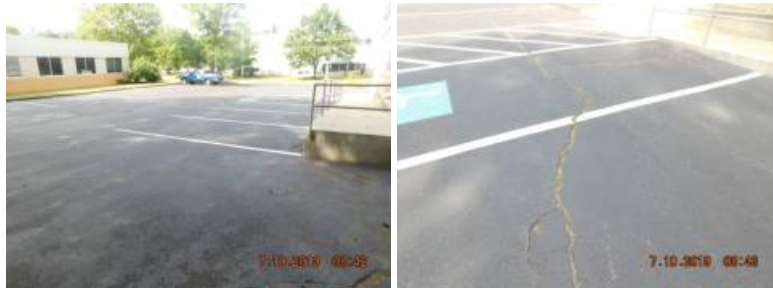
Parking Lot:

<i>Rating</i>	Defective.
<i>Location</i>	The parking lot is located at the, right.
<i>Material:</i>	The parking lot is constructed of, asphalt.
<i>Observations</i>	The parking lot, has irregular surfaces, is cracked, has trip hazards are noted.
<i>Recommendation</i>	The inspector recommends, fill the cracks, seal the surface to extend the life expectancy of the driveway Consult with a qualified professional to determine the full extent of repairs needed. This component requires, immediate repair or replacement.

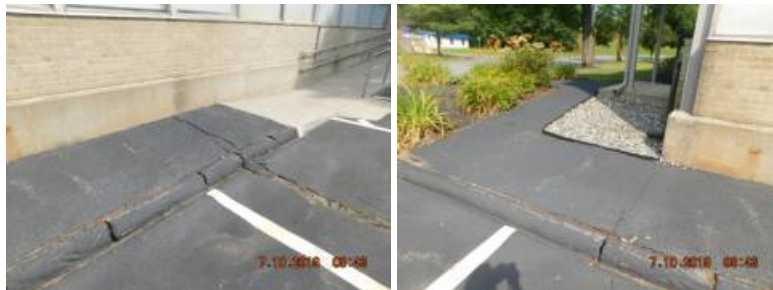
Walks

<i>Rating</i>	Limited repair.
<i>Location</i>	The walks are located at the, front, right.
<i>Material:</i>	The walks are constructed of: asphalt paving, concrete.
<i>Observations</i>	The walk, is cracked.
<i>Recommendation</i>	The inspector recommends fill the cracks and seal the walk surface to extend the life expectancy of the walk. This component requires, immediate repair or replacement.

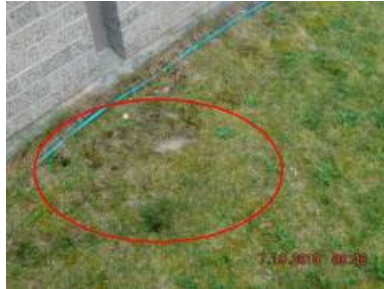
Site Grading:

<i>Rating</i>	Limited repair.
<i>Site:</i>	The site is mostly level.
<i>Observations</i>	The following conditions were noted at the time of the inspection: chipmunk burrows may

lead to sin holes

The inspector recommends contacting a pest control company for the control of chipmunks, This component requires, short term repair or replacement

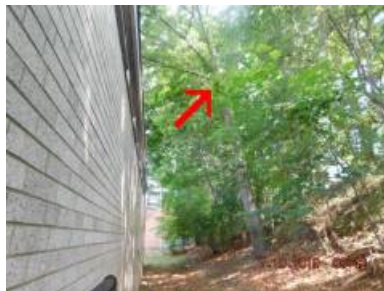
Defective.

The following conditions were observed at the time of the inspection
Trees are leaning at the building and should be removed
Trees are touching or overhanging the roof. Damage is possible. these trees should be trimmed

MBPI recommends remove overgrown trees that are leaning at the building. This component requires, short term repair or replacement.

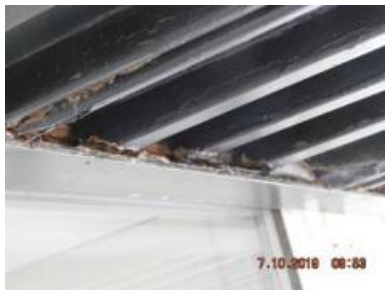
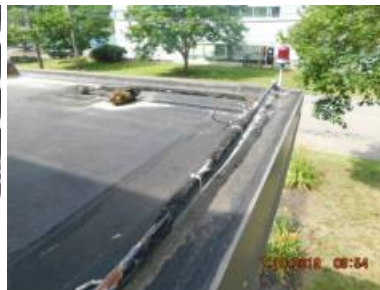
<i>Rating</i>	Defective.
<i>Style:</i>	Flat/low pitch.
<i>Access:</i>	Walked on roof.
<i>Material :</i>	The roof is surface is constructed of: adhered single ply rubber or EPDM membrane.
<i>Observations</i>	<p>The following conditions were observed at the time of the inspection: Signs of weathering and aging are present. Regular maintenance and inspections are advised. Improper materials have been used to repair the roof. Ponding is noted on roof. Ponding water on a roof causes leaks, algae and fungi growth. If left unattended, roof ponds can lead to the collapse of a roof. The size of roof ponds increases over time because the weight of the water causes additional deflection of the structural membranes underneath. Eventually, the structure will not be able to carry the increased load and the roof collapses.</p> <p>The metal decking at the front awning is deteriorated and requires replacement. The metal roof deck is oxidized, split, damaged, patches are noted. Evidence of leakage is noted.</p> <p>I.</p>

<i>Recommendation</i>	<p>The inspector recommends Repair this component. All repairs when implemented by the buyer, seller, and/or property owner shall comply with applicable requirements of the governing codes and sound construction practice Prior to closing of escrow the CLIENT should consult with roofing professional to determine the full extent of repairs or replacement, This component requires, short term repair or replacement.</p>

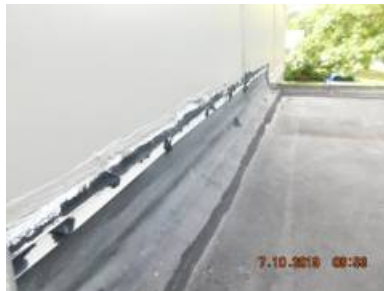
Step/Wall Flashing

Defective.

The following conditions were observed at the time of the inspection: the wall flashing at the front awning is improperly sealed, MBPI recommends Repair this component. All repairs when implemented by the buyer, seller, and/or property owner shall comply with applicable requirements of the governing codes and sound construction practice

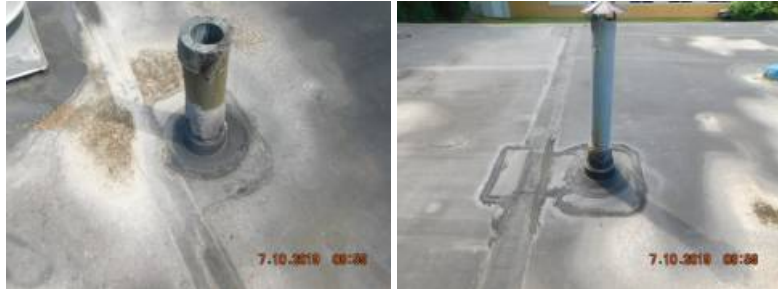
Plumbing vents

Limited repair.

The following conditions were observed at the time of the inspection: The flashing is sealed with a black asphalt like sealant. This is indicative of potential leakage.

MBPI recommends Repair this component. All repairs when implemented by the buyer, seller, and/or property owner shall comply with applicable requirements of the governing codes and sound construction practice

This component requires, short term repair or replacement.

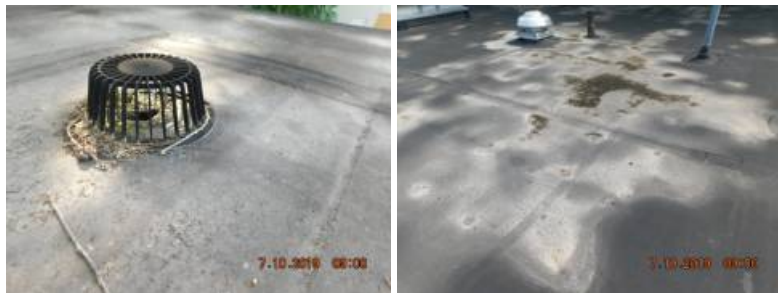
Exposed Roof Drainage:

Limited repair.

The following conditions were observed at the time of the inspection:
The roof drains are clogged with debris. This is causing water to pond on the roof which could lead to leaks and/or the eventual collapse of roof

MBPI recommends clean the drains, This component requires, immediate repair or replacement.

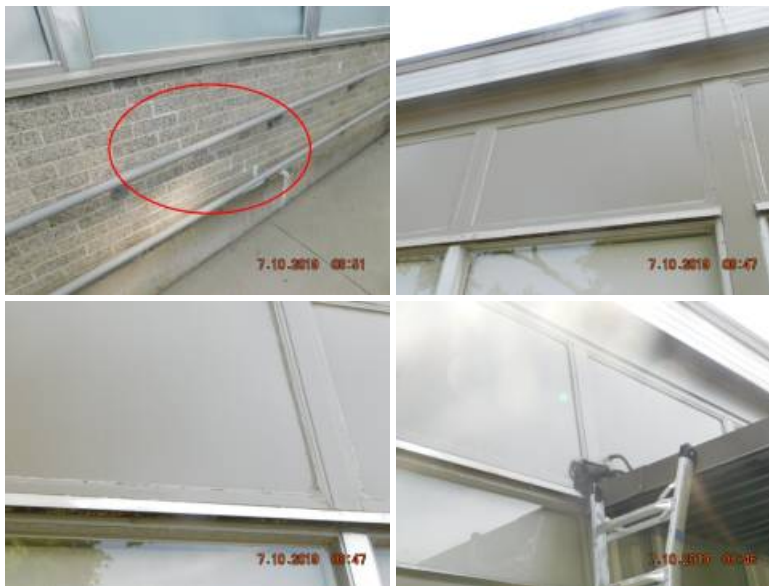
Exterior Wall Cladding:

<i>Rating</i>	Limited repair.
<i>Materials:</i>	The exterior siding is constructed of: wood panels and masonry.
<i>Observations</i>	The following conditions were observed at the time of the inspection: the wood framing at the panels is deteriorated. Improper material has been used to fill cracks in the mortar
<i>Recommendation</i>	MBPI recommends: Repair this component. All repairs when implemented by the buyer, seller, and/or property owner shall comply with applicable requirements of the governing codes and sound construction practice This component requires, short term repair or replacement.

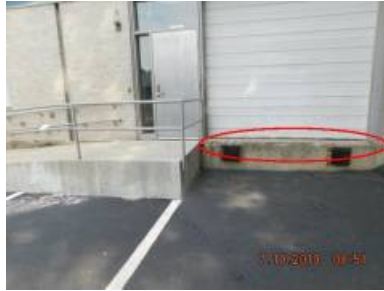
Rating Limited repair.

The following conditions were observed at the time of the inspection: The edge of the floor is cracked

MBPI recommends
 Repair this component. All repairs when implemented by the buyer, seller, and/or property owner shall comply with applicable requirements of the governing codes and sound construction practice
 This component requires, short term repair or replacement.

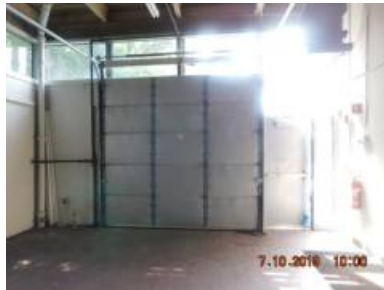
Overhead Doors:

Defective.

The following conditions were observed at the time of the inspection The door does not open fully

The inspector recommends repair or replace as needed, This component requires, short term repair or replacement.

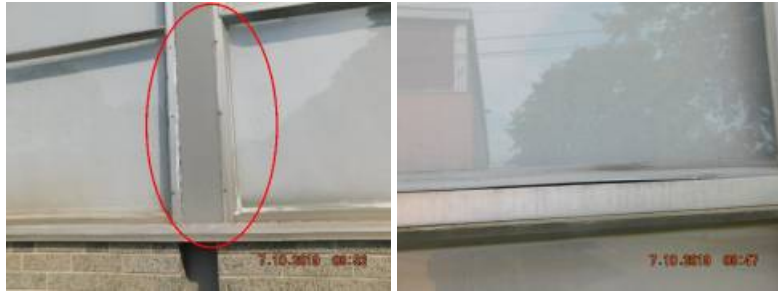
Trim

Limited repair.

The following conditions were observed at the time of the inspection: improperly sealed, the sealant is cracked.

MBPI recommends
 Repair this component. All repairs when implemented by the buyer, seller, and/or property owner shall comply with applicable requirements of the governing codes and sound construction practice
 This component requires, short term repair or replacement.

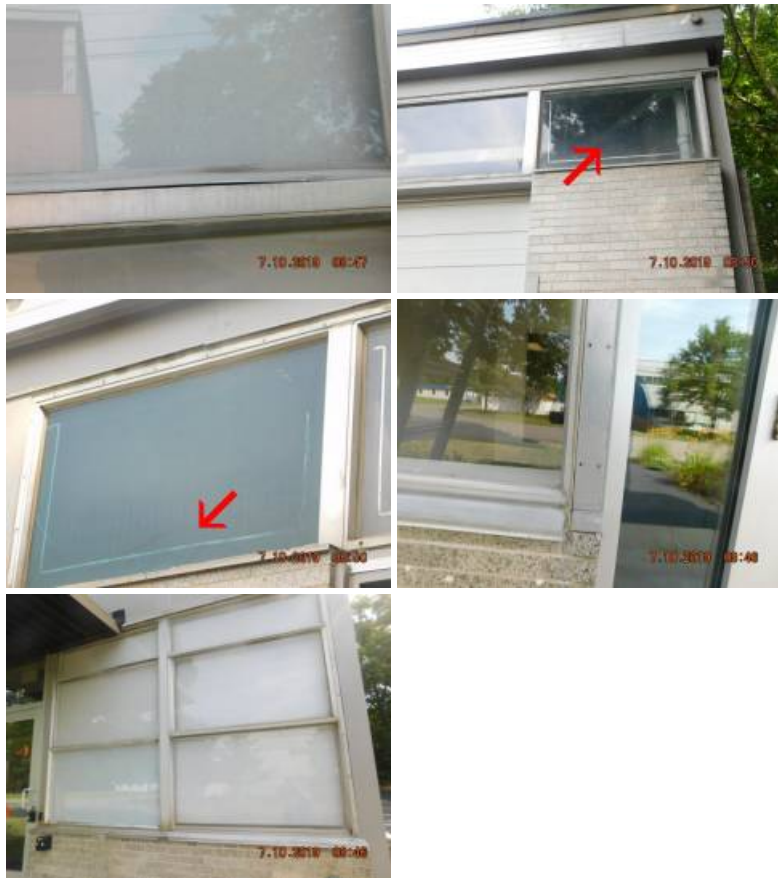
Windows

Defective.

The following conditions were observed at the time of the inspection: the sill and/or trim is cracked, improperly sealed, glass is broken, The windows do not conform to current standards of energy efficiency, This component is fully depreciated. The item inspected is no longer under the manufacturers warranty and it is suggested that it is reaching the end of its serviceable life, has no dollar or salvage value and replacement should be anticipated

Repair this component. All repairs when implemented by the buyer, seller, and/or property owner shall comply with applicable requirements of the governing codes and sound construction practice
seal windows and trim at wall joint
Upgrade with energy efficient windows.

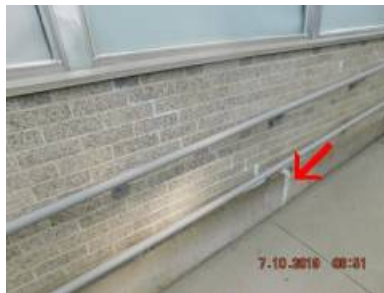
Foundation:

Rating Limited repair.

Observations The following conditions were observed at the foundation at the time of the inspection: the cracks are vertical, cracks are noted.

Recommendation MBPI recommends Repair this component. All repairs when implemented by the buyer, seller, and/or property owner shall comply with applicable requirements of the governing codes and sound construction practice seal all cracks to prevent water penetration into basement or crawl space, This component requires, short term repair or replacement.

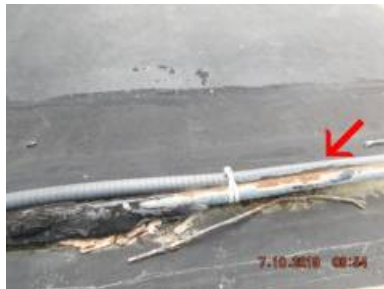
Rating Defective.

Observations: The following conditions were observed at the time of the inspection The conduit is oxidized

Recommendation The inspector recommends Repair or replace as needed. This component requires, short term repair or replacement.

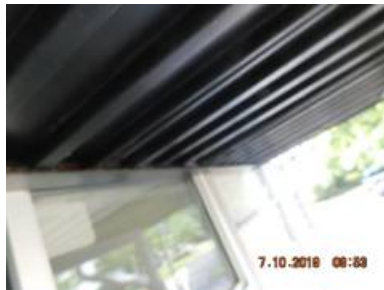
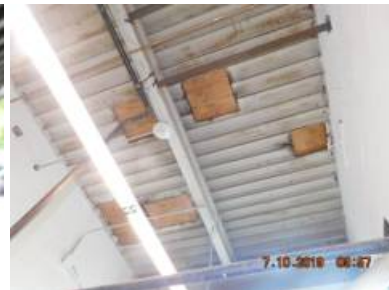
Rating Defective.

Observations The following conditions were observed at the time of the inspection: water damage the panels are deteriorated and oxidized. Portions of the panels are split. Patches opted in the panels. Evidence of roof leaks noted.

Recommendation MBPI recommends Repair this component. All repairs when implemented by the buyer, seller, and/or property owner shall comply with applicable requirements of the governing codes and sound construction practice, prior to closing the CLIENT should consult with qualified professional to determine the full extent of repairs, This component requires, immediate repair or replacement.

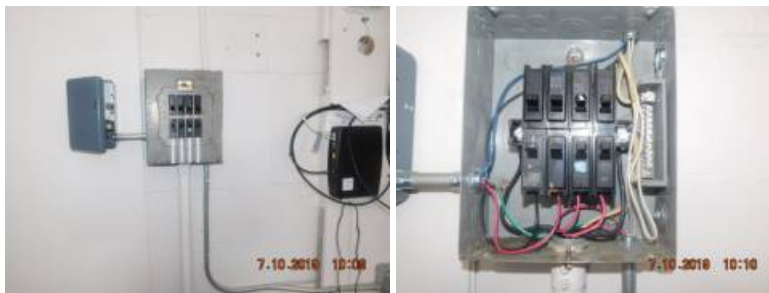
Defective.

The following conditions were observed at the time of the inspection: There are 2 distribution panels in the utility area, 1 is newer and in acceptable condition. The other distribution panel is outdated by today's standards. Upgrade should be considered. Repair this component. All repairs when implemented by the buyer, seller, and/or homeowner shall comply with applicable requirements of the governing codes and sound construction practice

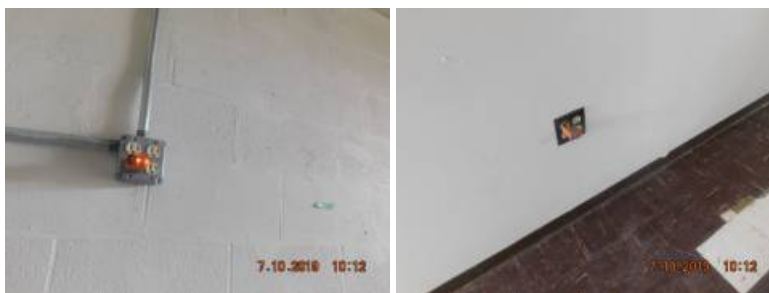
Defective, Safety Hazard.

The following conditions were observed at the time of the inspection: The outlets in the loading area are not GFCI protected Some outlets did not function.

MBPI recommends Ground Fault Circuit Interrupter (GFCI) outlets are recommended for installation at exterior, garage, bath rooms & kitchen outlets. This component requires, immediate repair or replacement.

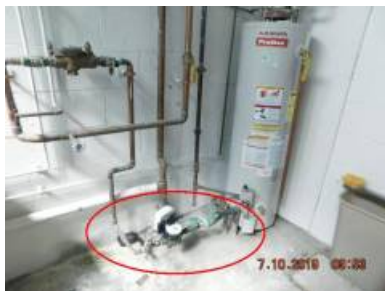
Main Line:

<i>Rating</i>	Limited repair.
<i>Type</i>	The potable water for this property is a, public system as noted in the subject listing, the electrical system is attached to both the city and dwelling side of the water piping, is bonded to the electrical system within 5 feet of its entry into the basement.
<i>Location:</i>	The water meter is located at the, water utility room.
<i>Material:</i>	copper.
<i>Functional Flow</i>	The functional flow appears adequate.
<i>Observations</i>	Older gate valves noted. These valves may leak when operated after years of no use. Corrosion is noted, No active leakage is noted at this time. Monitor in the future.
<i>Recommendations</i>	MBPI recommends, Repair this component. All repairs when implemented by the buyer, seller, and/or property owner shall comply with applicable requirements of the governing codes and sound construction practice the client consult with a licensed electrician to determine the full extent of repairs need prior to closing escrow This component requires, short term repair or replacement.

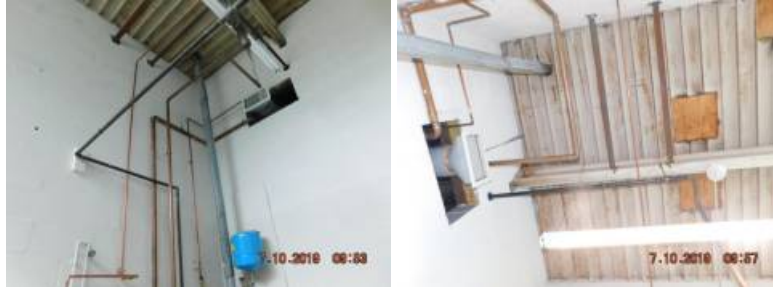
Supply Lines/Valves/Fittings:

the supply pipes are not insulated, Corrosion is noted at pipes valves and fittings. MBPI recommends, Repair this component. All repairs when implemented by the buyer, seller, and/or property owner shall comply with applicable requirements of the governing codes and sound construction practice insulate the pipes, This component requires, short term repair or replacement.

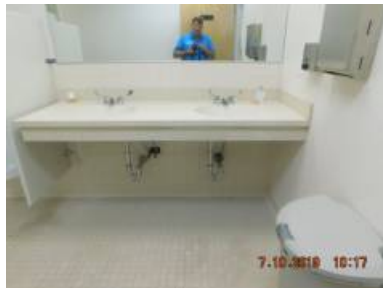
Limited repair. The sinks are missing insulated covers at the drains and valves. These covers are required in handicap accessible bathrooms.

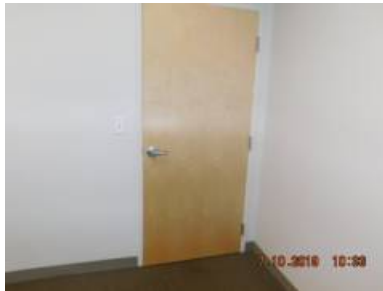
Observations The following conditions were observed at the time of the inspection:
Doors rub/stick/won't latch.

Recommendations MBPI recommends, Repair this component. All repairs when implemented by the buyer, seller, and/or property owner shall comply with applicable requirements of the governing codes and sound construction practice
This component requires, short term repair or replacement.

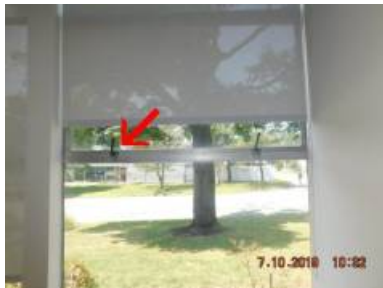
Windows

Rating Defective.

Observations The following conditions were observed at the time of the inspection:
Locking hardware needs repair or replacement, There is at least one broken window pane.

Recommendations MBPI recommends, Repair this component. All repairs when implemented by the buyer, seller, and/or property owner shall comply with applicable requirements of the governing codes and sound construction practice
This component requires, placement of the reserve term repair list.

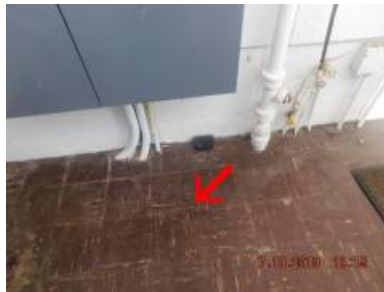
Observations The following conditions were observed at the time of the inspection: The floor covering is, worn, cracked. 9x9 tiles may or may not contain asbestos.

Recommendations MBPI recommends, Repair this component. All repairs when implemented by the buyer, seller, and/or property owner shall comply with applicable requirements of the governing codes and sound construction practice
This component requires, immediate repair or replacement.
