**Inspection reference: 0000-Sample**

# **Confidential Inspection Report**

**1 Any Street**  
**Sharon, MA 02067**

**September 15, 2019**

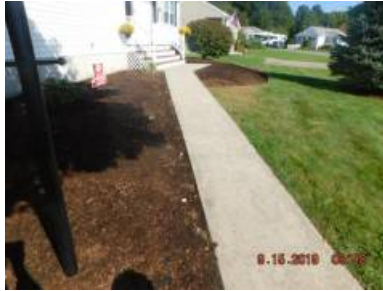
Maintenance Required, The walk, is cracked, repair as needed.

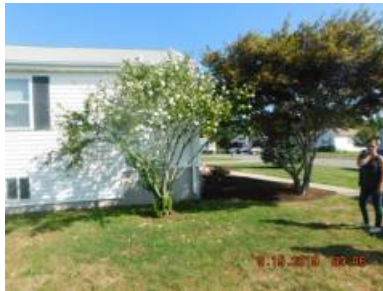
Maintenance Required, The trees, are touching or overhanging the building. Damage is possible. these trees should be trimmed

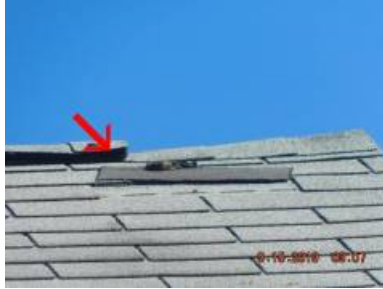
Maintenance Required, Fully Depreciated. the asphalt shingle roof surface has missing or damaged shingles A qualified roofing contractor is recommended for further evaluation and to estimate repairs.

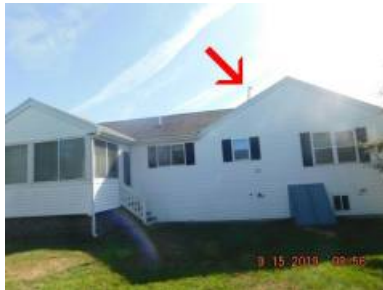
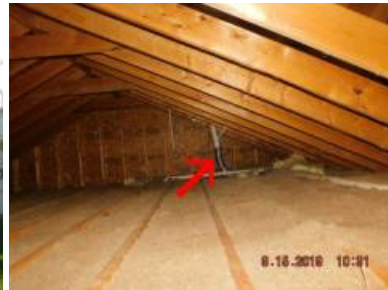
Maintenance Required, The bathroom fan vent pipe is leaning and improperly secured. Repair or replace as needed, A qualified contractor is recommended for further evaluation and to estimate repairs.

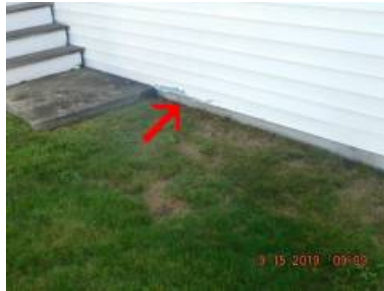
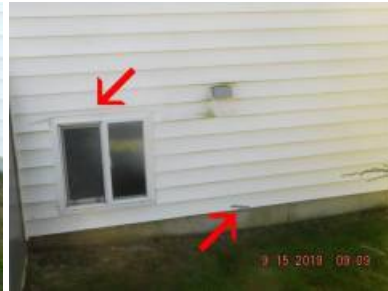
Maintenance Required, The following conditions were noted, The siding is cracked/split, Repair or replace as needed, A qualified contractor is recommended for further evaluation and to estimate repairs.

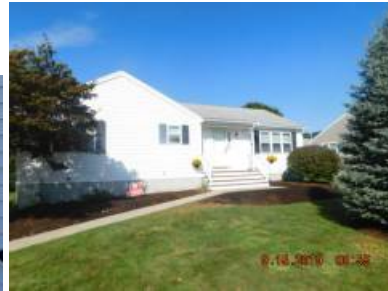
Repair/Replace/ Upgrade, The hand and or guard railings are, not graspable, Repair or replace as needed, A qualified contractor is recommended for further evaluation and to estimate repairs.

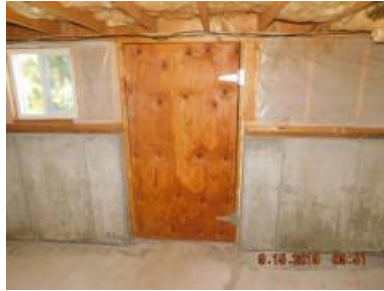
Repair/Replace/ Upgrade, The door and frames are have improper weather stripping, daylight is visible around the door frame, not plumb, The doors do not conform to current standards of energy efficiency, Replace door with a modern energy efficient door, A qualified contractor is recommended for further evaluation and to estimate repairs.

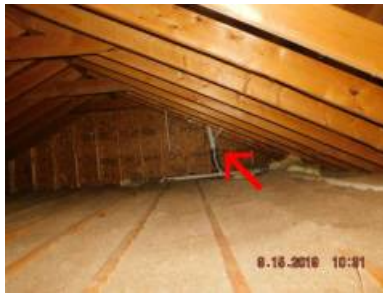
*Comments:* Maintenance Required, the vent pipe in the attic is improperly secured, Repair or replace as needed.

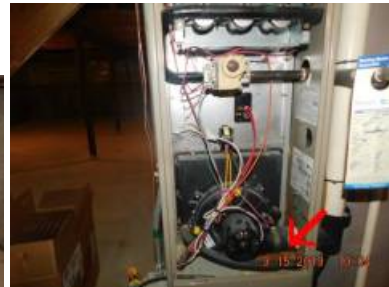
*Comments:* Fully Depreciated. The sheet metal housing, is oxidized, anticipate the need for replacement in the near future, A qualified contractor is recommended to evaluate and estimate repairs

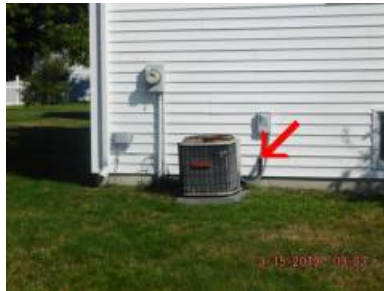
Maintenance Required, The insulation for the cold gas line is damaged/deteriorated, Repair or replace as needed.

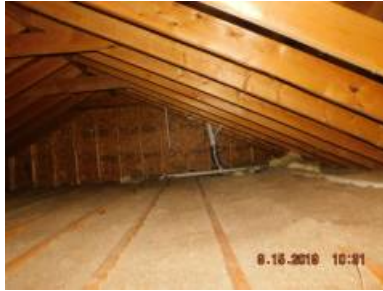
*Type/Depth:* The visible insulation consists of, Cellulose- Blown in type.  
*Comments:* Repair/Replace/ Upgrade, Insufficient. The amount of insulation does not conform to modern standards of energy efficiency, Additional insulation is recommended.

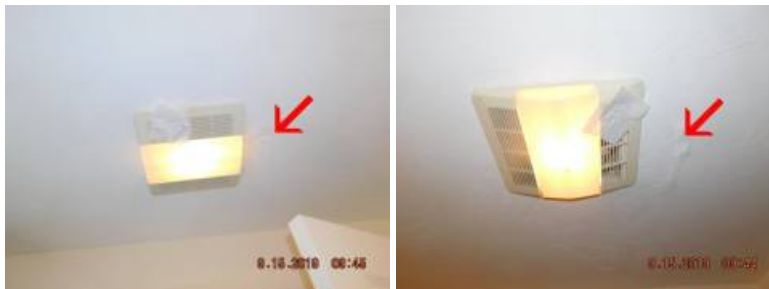
Comments: Maintenance Required, water damage noted at the bathroom fans, Repair or replace as needed. A qualified licensed contractor is recommended for further evaluation and to estimate repairs.

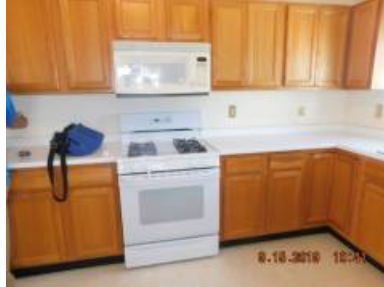
Repair/Replace/ Upgrade, Safety Hazard, Stove has not been secured as required by manufacturer's installation instructions. A tip-over hazard exists. Stove should be properly secured right-away. Repair or replace as needed. A qualified licensed contractor is recommended for further evaluation and to estimate repairs.
