Inspection reference: Sample 40,000 SF Warehouse

Confidential Inspection Report

Inspection: Sample 40,000 SF Warehouse Address: Any Street

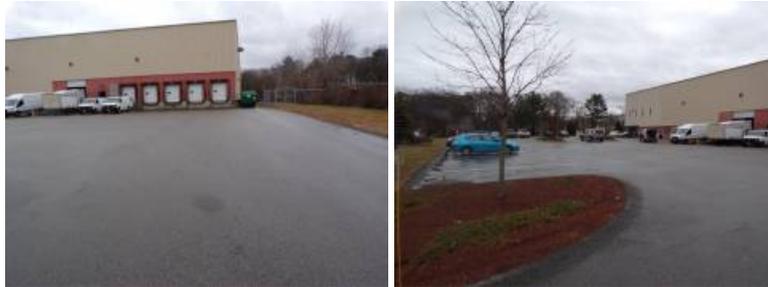
Parking Lot:

<i>Rating</i>	Limited repair.
<i>Material:</i>	The parking lot is constructed of, asphalt.
<i>Observations</i>	The parking lot, has irregular surfaces, is cracked.
<i>Recommendation</i>	The inspector recommends, fill the cracks, seal the surface to extend the life expectancy of the driveway, Consult with a qualified professional to determine the full extent of repairs needed.

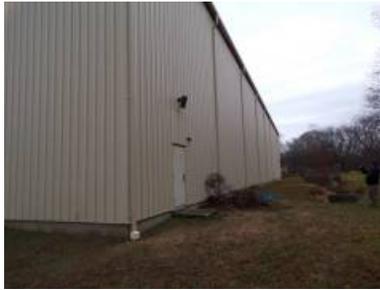
Site Grading:

<i>Rating</i>	Limited repair.
<i>Site:</i>	The site is mostly level.
<i>Observations</i>	The site has irregular surfaces and is wet.
<i>Recommendation</i>	The inspector recommends Repair this component. All repairs when implemented by the buyer, seller, and/or homeowner shall comply with applicable requirements of the governing codes and sound construction practice Consult with a qualified professional to determine the full extent of repairs needed.

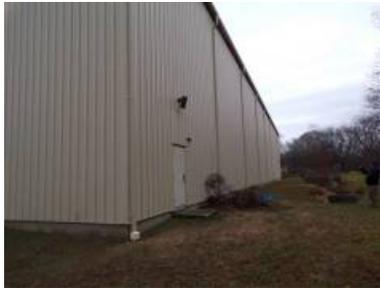
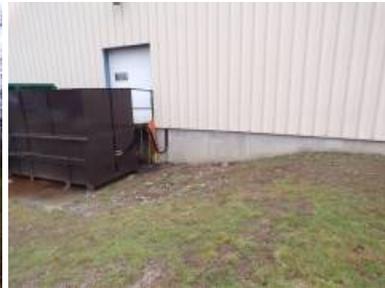
Grading at Foundation

Defective.

The following conditions were observed at the time of the inspection negative drainage toward building.

Repair this component. All repairs when implemented by the buyer, seller, and/or homeowner shall comply with applicable requirements of the governing codes and sound construction practice

Consult with a qualified professional to determine the full extent of repairs needed.

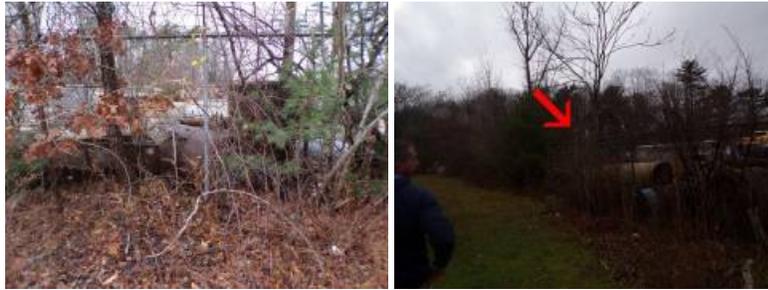
Fence

Defective.

The fence is constructed of: chain link.

The fence is leaning, The fence is damaged, The fence panels improperly secured.

Repair this component. All repairs when implemented by the buyer, seller, and/or homeowner shall comply with applicable requirements of the governing codes and sound construction practice

Consult with a qualified professional to determine the full extent of repairs needed.

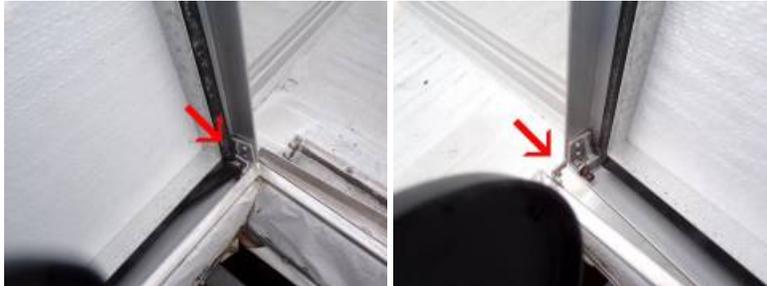
Skylights:

Defective.

The roof hatch is broken at the hinge.

The inspector recommends repair or replacement of the roof hatch

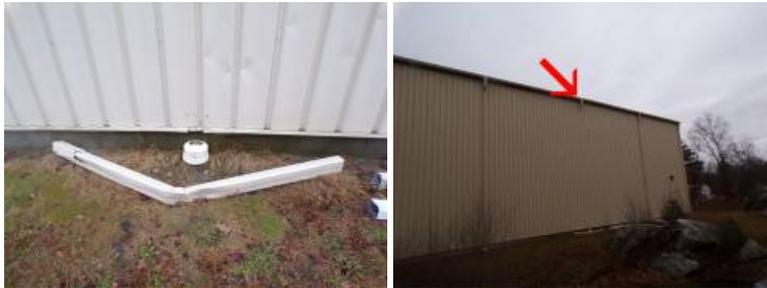
Exposed Roof Drainage:

Defective.

Gutters and down spouts are only partially installed, the gutters and downspouts are located at the rear.

The following conditions were observed at the time of the inspection:
The gutters and/or downspouts are improperly secured. The gutters and downspouts are missing components
The gutters appear to be leaking.

Prior to closing of escrow the client should:
Repair this component, properly secure all gutters and downspouts to prevent collapse of the system and to allow roof water to properly drain away from the dwelling, The CLIENT should consult with a qualified contractor to determine the full extent of repairs need, hidden or concealed damage may be present.

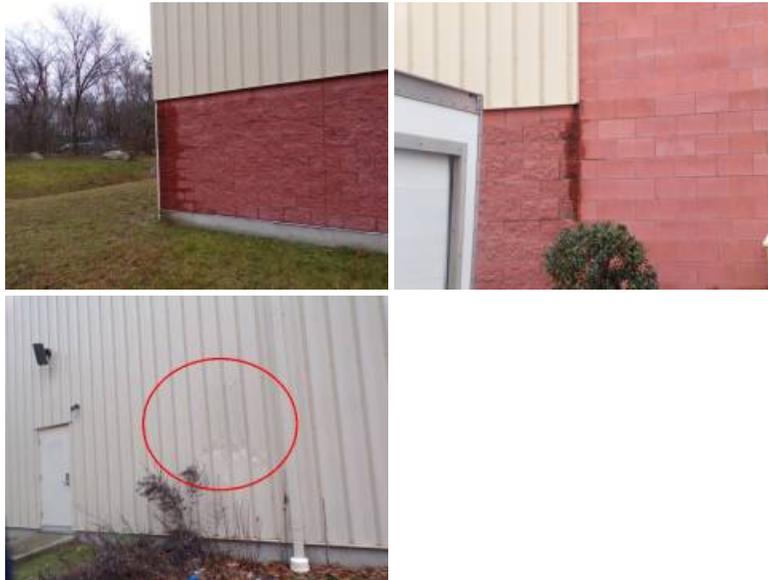
Exterior Wall Cladding:

<i>Rating</i>	Limited repair.
<i>Materials:</i>	The exterior siding is constructed of: corrugated metal and masonry blocks.
<i>Observations</i>	The following conditions were observed at the time of the inspection: Dents/damage noted at the metal walls at the right side and the rear Water penetration noted at the rear left corner and at the front by the overhead doors.
<i>Recommendation</i>	Consult with appropriate contractor to determine the full extent of repairs necessary.

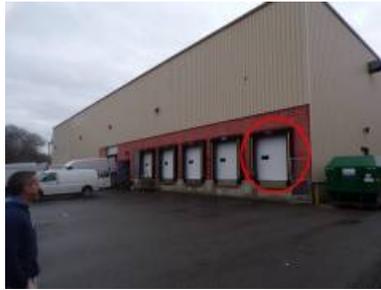
Loading Dock

<i>Rating</i>	Limited repair.
<i>Observations</i>	The bumpers are damaged.
<i>Recommendation</i>	Replacement of the damaged bumpers.

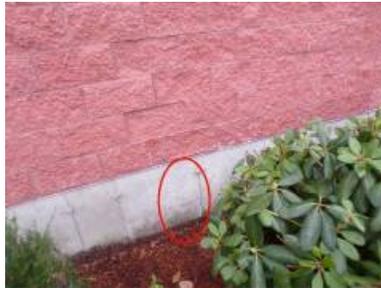
Foundation:

Limited repair.

The structure is supported by, a permanent foundation, The foundation is constructed of: Poured in place slab concrete, 8 inches or more thick.

The following conditions were observed at the foundation at the time of the inspection: cracks are noted, the cracks are vertical, Shrinkage cracks are hairline cracks that are caused by the evaporation of water in the mix. This is a normal condition. Seventy-five percent of all shrinkage cracks appear in the first year.

Prior to closing of escrow the client should: seal all cracks to prevent water penetration into basement or crawl space.

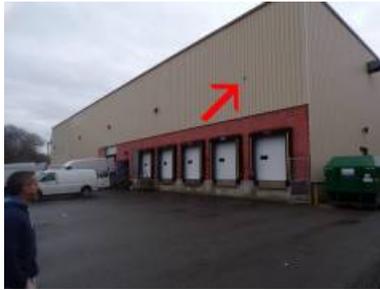
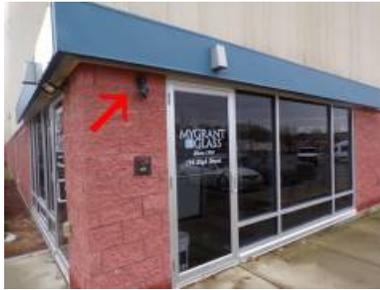
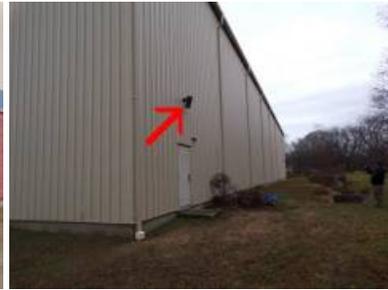
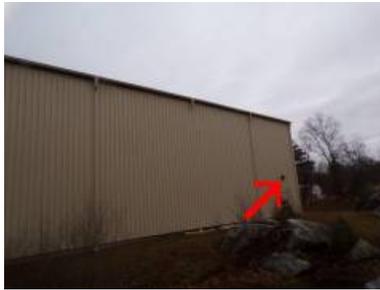
Exterior Lighting:

Defective, Safety Hazard.

The following conditions were observed at the time of the inspection
Some exterior lights were improperly secured
Some of the exterior doors, steps and landings were missing lights

The inspector recommends repair or replace as needed.

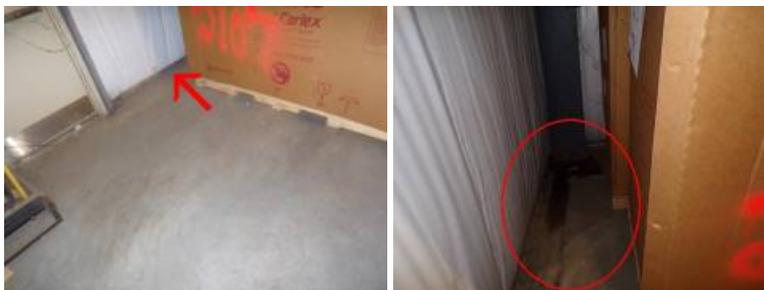
Foundation:

Defective.

The following conditions were observed at the time of the inspection
Movement is noted in the rear right corner of the foundation
Shrinkage cracking was noted on at least one wall. Shrinkage cracking is the result of moisture in the concrete walls evaporating and shrinking. This generally is not a cause for concern as all concrete shrinks. Should any of these cracks begin to grow, then further attention and evaluation would be recommended.
Water penetration/efflorescence noted.

The client should review the foundation with a structural engineer to determine if this is an ongoing condition.

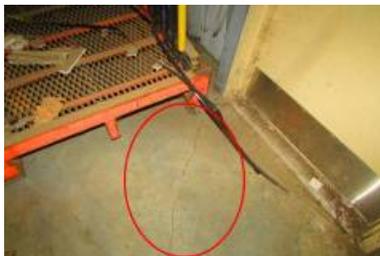
Basement Floor

Defective.

The following conditions were observed at the time of the inspection
Cracks were noted in the slab floor. Unless otherwise noted, the cracks appear to be from movement.

The client should review the foundation with a structural engineer to determine if this is an ongoing condition.

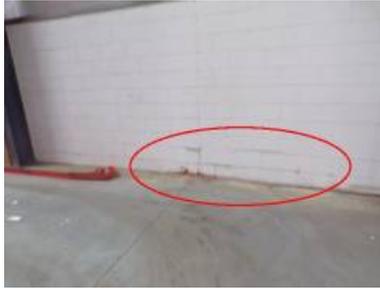
Warehouse Walls

Limited repair.

The following conditions were observed at the time of the inspection
Minor cracks and damage noted at the masonry walls in the back left corner.

Repair this component. prior to closing the CLIENT should consult with qualified professional to determine the full extent of repairs.

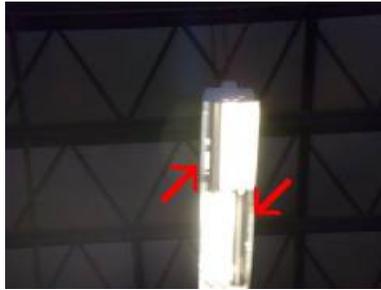
Basement Lighting:

Defective.

Some basement lights failed to operate

Some of the basement doors, steps and landings were missing lights

The inspector recommends repair or replace as needed, Have a licensed electrician make further evaluation and corrections as needed.

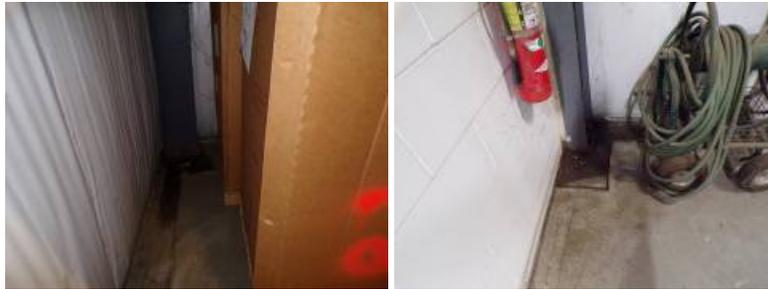
Moisture Control

Limited repair.

Water penetration noted at rear left and rear right corners.

prior to closing the CLIENT should consult with qualified professional to determine the full extent of repairs.

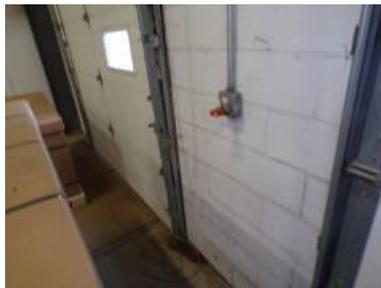
Electrical Outlets:

Limited repair.

The following conditions were observed at the time of the inspection:
GFCI protection is not present at the overhead doors.

Prior to closing of escrow the client should
Ground Fault Circuit Interrupter (GFCI) outlets are recommended for installation at outlets by the overhead doors.

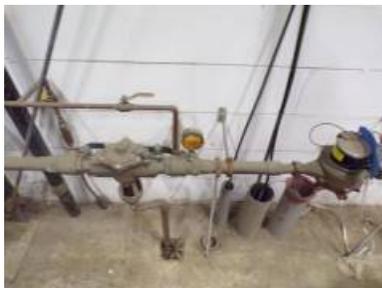
Main Line:

<i>Rating</i>	Limited repair.
<i>Type</i>	public system as noted in the subject listing.
<i>Material:</i>	copper.
<i>Functional Flow</i>	The functional flow appears adequate.
<i>Observations</i>	the electrical system is not attached to both the city and dwelling side of the water meter, The main water supply pipes are not bonded to the electrical system within 5 feet of its entry into the basement. Corrosion is noted, the pressure gauge is damaged.

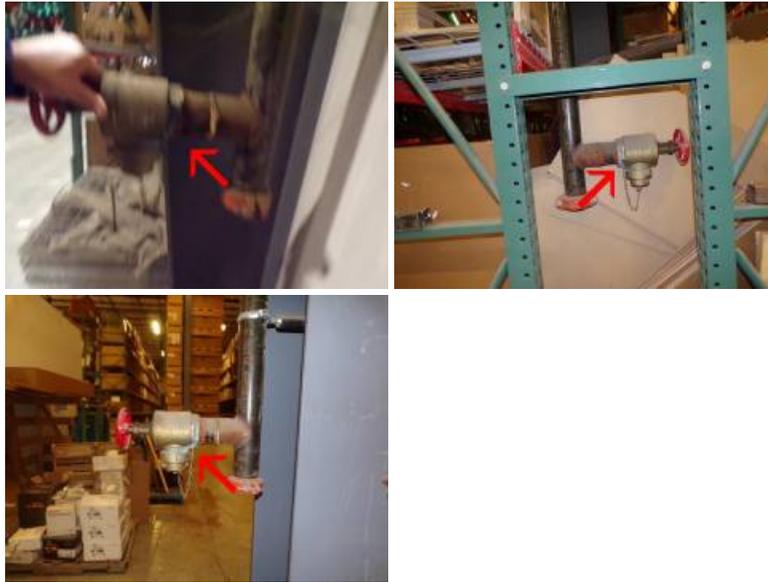
Fire Suppression System

<i>Rating</i>	Limited repair.
<i>Material:</i>	copper, black pipe.
<i>Observations</i>	Corrosion is noted, repair or replace as needed. A qualified plumber is recommended for further evaluation and to estimate repairs.

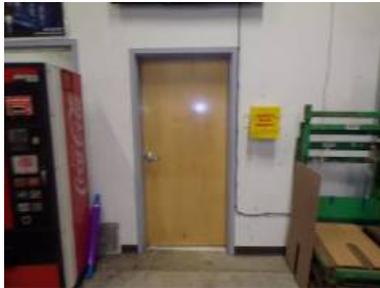
Rating Limited repair.

Observations The following conditions were observed at the time of the inspection:
Doors rub/stick/won't latch.

Recommendation The inspector recommends
Repair this component. All repairs when implemented by the buyer, seller, and/or homeowner shall comply with applicable requirements of the governing codes and sound construction practice
